Resistance of Alkali-activated Slag Cement Against Sodium Sulfate

A. Allahverdi^{1,2*}, H. Hashemi¹, M. Mahinroosta¹

Abstract: This work evaluates the resistance of alkali-activated slag (AAS) mortar against sodium sulfate attack. The effects of immersion in 5% sodium sulfate solution under room temperature and wetting-drying cycles on the compressive strength of mortar specimens were considered to evaluate the extent of degradation. Mortar specimens prepared from type II and V Portland cements (PC2 and PC5) in accordance with ASTM standard were also used as a reference. To characterize the chemical products of the degradation process due to sodium sulfate attack, the specimens were also studied by X-ray diffractometry, scanning electron microscopy, and the elemental analysis by energy-dispersive X-ray spectroscopy. After 360 days of exposure to the sodium sulfate solution, PC2, PC5 and AAS cements showed 71, 52 and 45% reduction in compressive strength, respectively. According to the obtained results, AAS cement exhibits a higher sulfate resistance compared to PC2 and PC5.

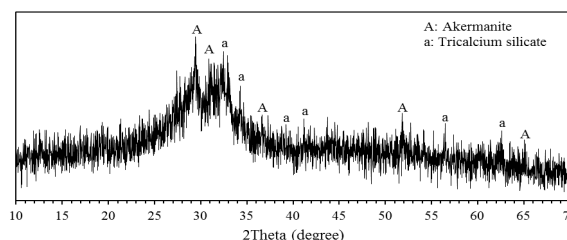
Fig. 1. X-ray diffraction pattern of BFS.

Fig. 1 shows the XRD pattern of BFS. As can be seen, the BFS is mainly amorphous and consists of few amounts of crystalline phases including akermanite ($\text{Ca}_2\text{MgO}_7\text{Si}_2$) and tricalcium silicate (Ca_3SiO_5). These phases were identified based on ICDD standard cards of 01-083-1815 and 01-086-0402, respectively. The tricalcium silicate originates from the reaction between CaO and SiO_2 existed in the melt during the high temperature production process of the BFS.

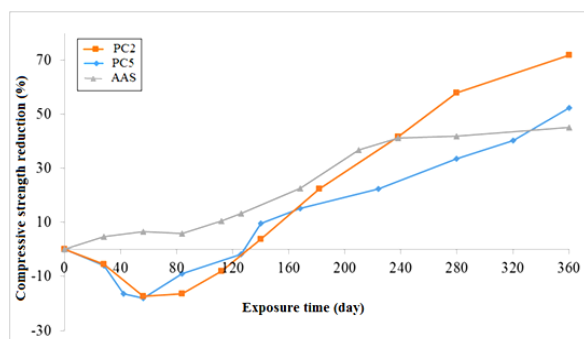
Fig. 6. Compressive strength reduction of specimens subjected to sodium sulfate solution.

To clarify the resulting conclusions, the measured compressive strengths at different time intervals were compared with the corresponding initial values (28-day compressive strengths) and the percentage of the strength reductions were calculated and presented graphically in Fig. 6.

The strength reductions after 360 days of exposure for AAS, PC5, and PC2 are 45%, 52% and 71%, respectively. All the three tested cements are more or less vulnerable to sodium sulfate attack. The strength reductions of PC2 and PC5, however, are almost 1.6 and 1.2 times higher than that of AAS, respectively. AAS mortar specimens therefore exhibit a better resistance against sodium sulfate over prolonged exposure time. This result will also be confirmed by further studies in following sections.

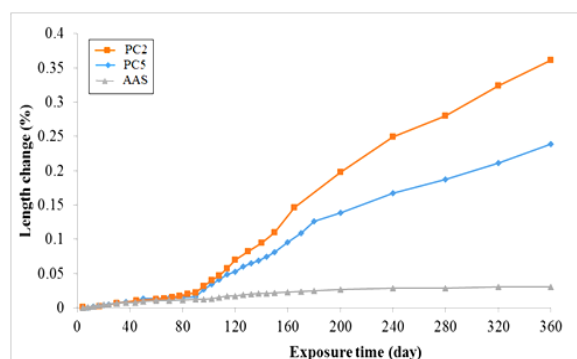
Fig. 7. Length change of PC2, PC5, and AAS mortar bars versus exposure time to sodium sulfate solution.

The length changes of PC2, PC5, and AAS mortar bars in terms of exposure time to sodium sulfate solution are presented in Fig. 7.

As can be observed in this figure, after about 80 days of exposure to sodium sulfate solution, PC2, PC5, and AAS specimens attained almost the same slight length changes. With continued exposure, the length changes of AAS specimens found a tremendous difference with PC2 and PC5 specimens, so that after 360 days of exposure the PC2, PC5, and AAS mortar bars exhibited 0.36%, 0.24%, and 0.03% length changes, respectively.

The obtained results show that AAS mortar bars attained a negligible amount of length change compared to PC2 and PC5 mortar bars. The expansion in PC2 and PC5 is due to the formation of voluminous destructive products such as gypsum and ettringite. In the case of AAS mortar, since BFS does not contain C_3A phase, the probability of the formation of ettringite as

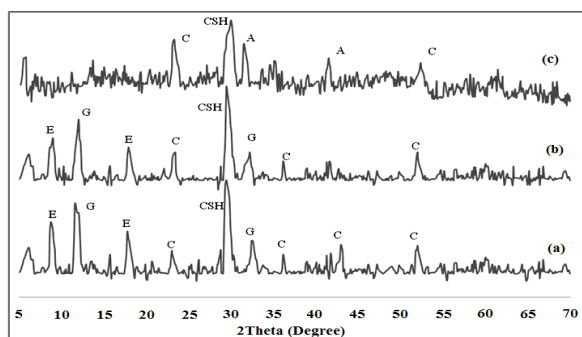
Fig. 9. XRD patterns of paste specimens exposed to 5% sodium sulfate solution: (a) PC2, (b) PC5, and (c) AAS. (E=Ettringite, G=Gypsum, C=Calcite, CSH= calcium silicate hydrate, A=Akermanite).

Samples were also prepared and analyzed from exposed paste specimens to characterize the chemical products of the degradation process. The obtained diffraction patterns are presented in Fig. 9. As seen, no gypsum and ettringite are present in the AAS sample, whereas considerable amounts of ettringite and gypsum were found in PC samples.

Upon sulfate attack, the calcium hydroxide present in Portland cement paste directly combines with sulfate ions leading to the formation of gypsum. The alumina-containing hydrates of the Portland cement paste are also converted to ettringite. Formation of these voluminous compounds leads to expansion, cracking, and loss of compressive strength [8, 13, 16]. For the PC pastes, the obtained diffraction patterns are in complete agreement with experimental observations and the mechanisms given in the literature. For AAS paste, however, the experimental observations and the obtained diffraction pattern are completely different compared to PC pastes. As seen, the XRD pattern of AAS paste showed no degradation products. The mechanism of deterioration due to sodium sulfate attack in AAS paste is, of course, different due to its different chemical and mineralogical phase compositions.

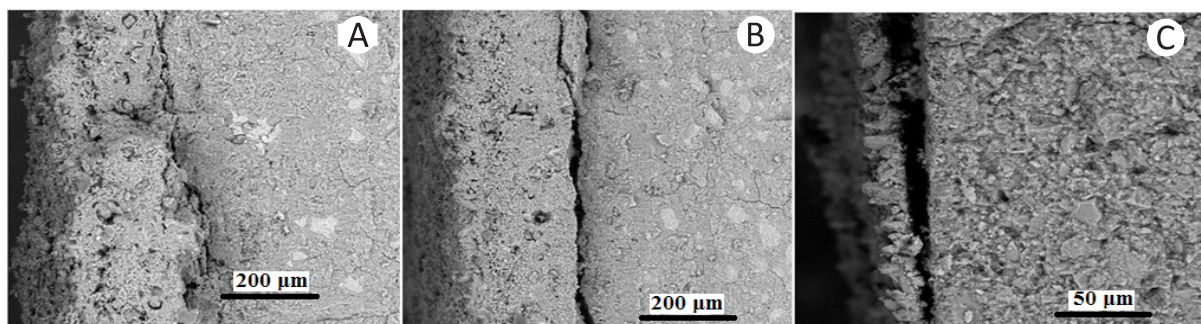
Fig. 10. SEM images (BSE mode) from cross sections of regions close to the exposed surfaces of the A) PC2, B) PC5, and C) AAS paste specimens.

Fig. 10 shows BSE mode SEM images from cross-sections of regions close to the exposed surfaces of the PC2, PC5, and AAS paste specimens after 360 days of exposure.

As can be observed from Figs. 10A and 10B,

sulfate attack has caused a loose and porous surface layer in PC2 and PC5 paste specimens that is highly cracked. This is a soft surface layer that showed no or quite less adhesion and strength. In the case of AAS paste specimens (Fig. 10C), a detached surface layer can be seen.
