INFLUENCE OF HEAT TREATMENT PARAMETERS, TEMPERATURE AND TIME, ON WEAR AND MICROHARDNESS OF NiCrBSi FLAME SPRAYED COATINGS APPLIED ON CK45 SUBSTRATES

H. Arabi^{1,2 *}, S. Rastegari², V. Ramezani² and Z. Valefi³

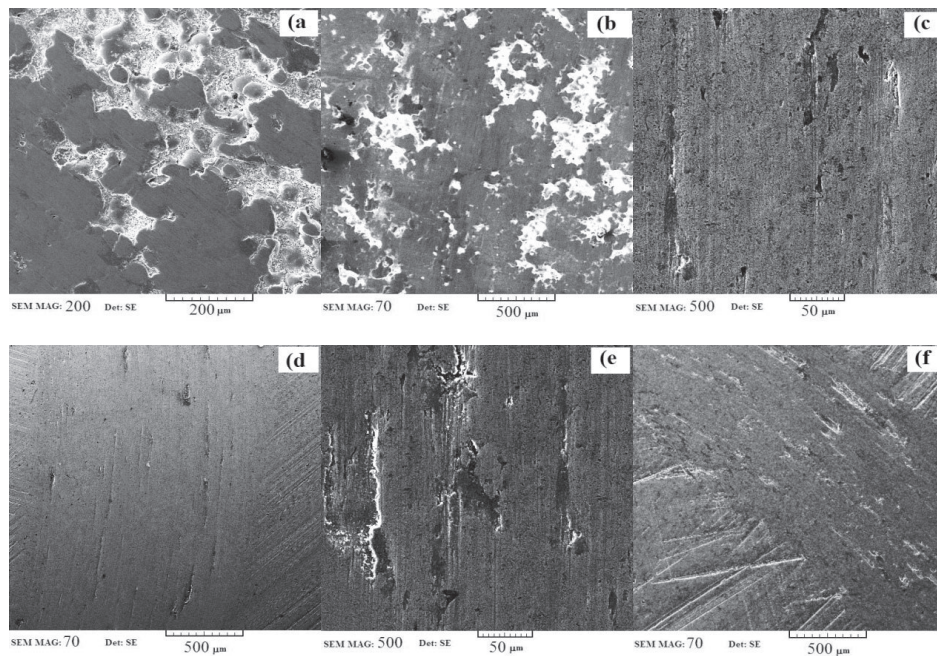
**Fig. 2.** SEM micrographs of worn surfaces of (a) and (b) 00-S-5, (c) and (d) 75-S-5, (e) and (f) 75-S-15 samples

samples are presented in Fig. 2 and their corresponding debris of these worn surfaces in Fig. 3. Fig. 3 shows the debris obtained from the sample 00-S-5 are large and have platelet morphology, while those obtained from sample 50-S-5 are smaller and have both polygonal and platelet shapes. The debris obtained from 75-S-5 and 75-S-15 samples were polygonal, however the mean size of 75-S-5 sample's debris was smaller than that obtained from 75-S-15 sample. In

addition, some of the worn areas on sample 00-S-5 contain very wide and deep grooves and it seems that they were formed due to pull out of the coating splats from the coated surface, while the grooves observed in 75-S-5 and 75-S-15 samples are mainly parallel scratches rather than pull out of splats.

Considering the topography of the worn surface of 00-S-5 sample (Fig. 2a and b), one can observe the splats were pulled out from the

coating surface due to weak cohesive force between the splats. The pull out of the splats during wear test of this type of coating seems to be due to fatigue wear as reported in a similar research by Miguel et al [9]. This mechanism was the dominate wear mechanism in the 00-S-5 sample. On the other hand, the dominate wear mechanism of the sample 75-S-5 seems to be abrasive wear as the parallel scratches observed on the worn surface can be an indication of abrasive wear (Fig. 2c and d). Over the worn coating surface of the sample 75-S-15 parallel scratches can be observed and it seems abrasive wear mechanism was also dominant in this sample.

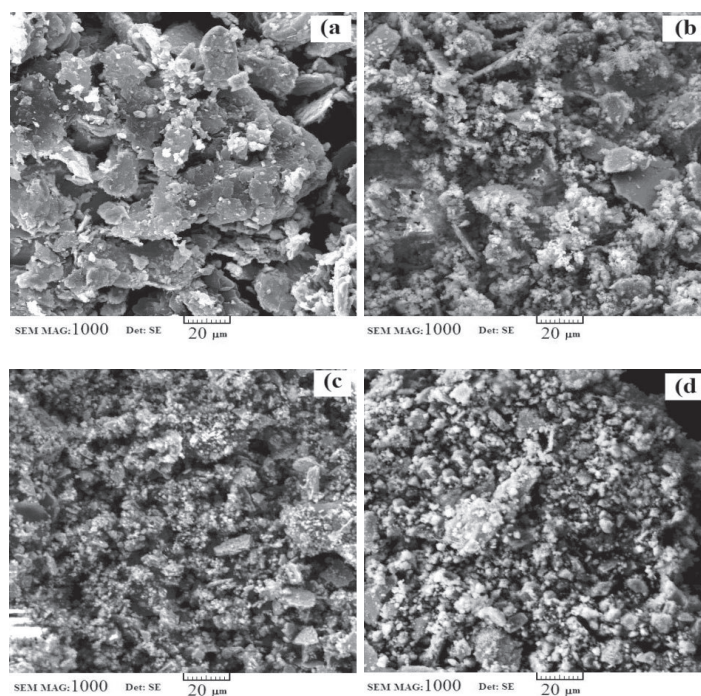
Fig. 3. SEM micrographs of the debris obtained from (a) 00-S-5, (b) 50-S-5, (c) 75-S-5 and (d) 75-S-15 samples

The mean size of precipitates in 75-S-5 and 75-S-15 samples were 1.2 μm and 3.4 μm respectively. Looking at the debris sizes obtained from the worn surface (Fig. 2) and compare them with the sizes of precipitates observed in the cross section of these coatings (Fig. 4), one may justifies the differences observed in the debris sizes obtained from the worn coatings. The bigger debris produced from 75-S-15 sample is actually due to larger sizes of precipitates existed

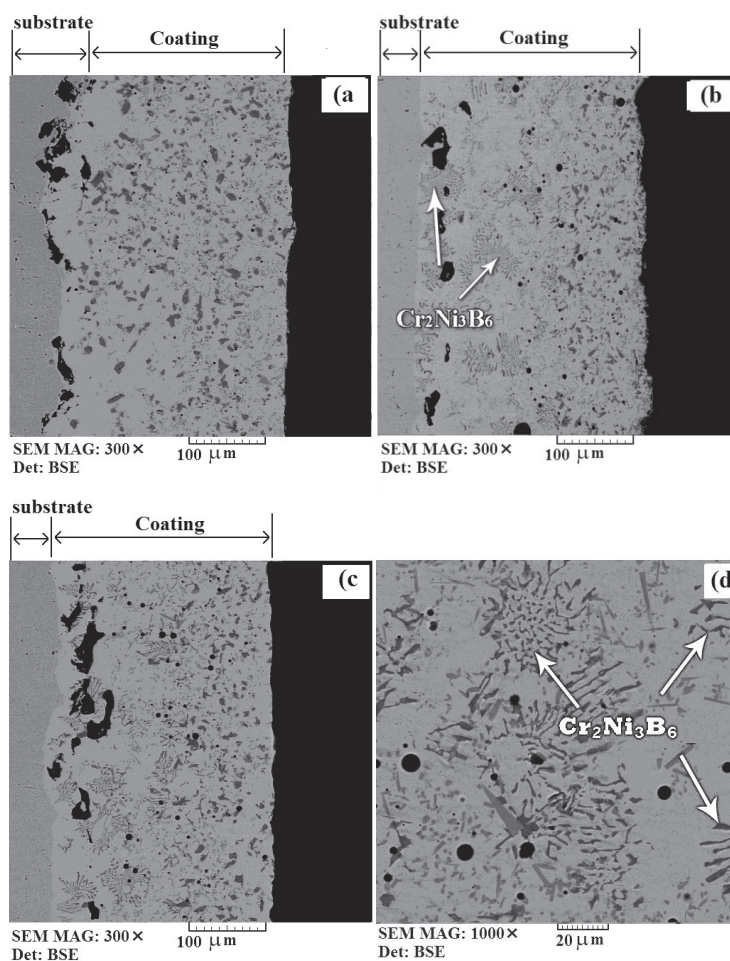
Fig. 5. SEM micrographs of cross section of (a) 75-S-15, (b) 100-S-10, (c) 100-S-15 and (d) 100-S-10 at higher magnification than Fig.4

precipitates were identified as CrB, $(\text{Cr,Fe})_7\text{C}_3$, Ni_5Si_2 and Ni_3B . It should be mentioned that CrB and $(\text{Cr, Fe})_7\text{C}_3$ were identified by EDS analysis, while Ni_5Si_2 and Ni_3B could not be characterized by EDS due to the negligible difference exit between their atomic weight and coating matrix (i.e. Ni), therefore they were identified by XRD analysis. Within the microstructures of the samples treated at 1100 °C for 10 and 15 minute a new phase with a stoichiometric composition $\text{Cr}_2\text{Ni}_3\text{B}_6$ was detected. This phase which was not observed within all other samples formed within the coating in the vicinity of the substrate of 100-S-10 and 100-S-15 samples, Fig. 5.

distance of 150 μm from its interface from the substrate. This observation might be related to the formation of $\text{Cr}_2\text{Ni}_3\text{B}_6$ precipitates in 100-S-15 sample that was mentioned in previous sections. The coating microstructure of this sample can be seen in Fig. 5.

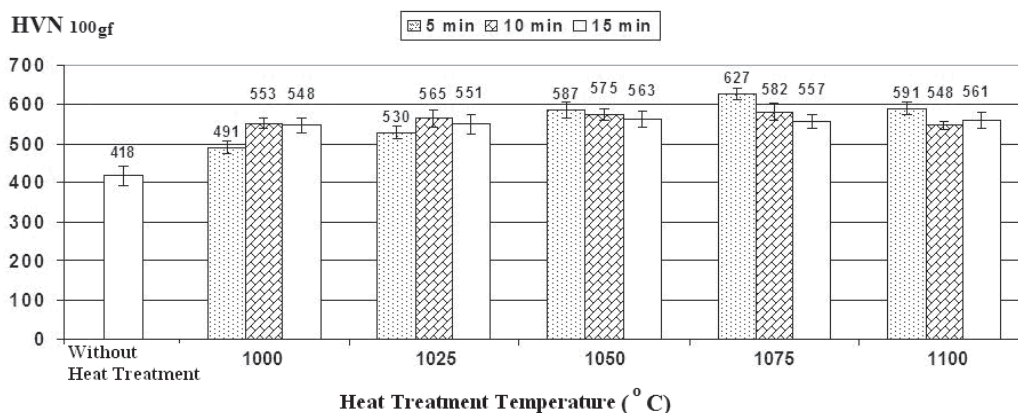
Fig. 7. The mean microhardness profile of substrate/coating cross section of coatings treated at various temperatures and 15 minutes

Fig. 7 shows when the time of heat treatment increased from 5 to 15 minutes only a little change occurred in hardness values, but the sample treated for 15 minute at 1100 °C lost its hardness substantially particularly up to a

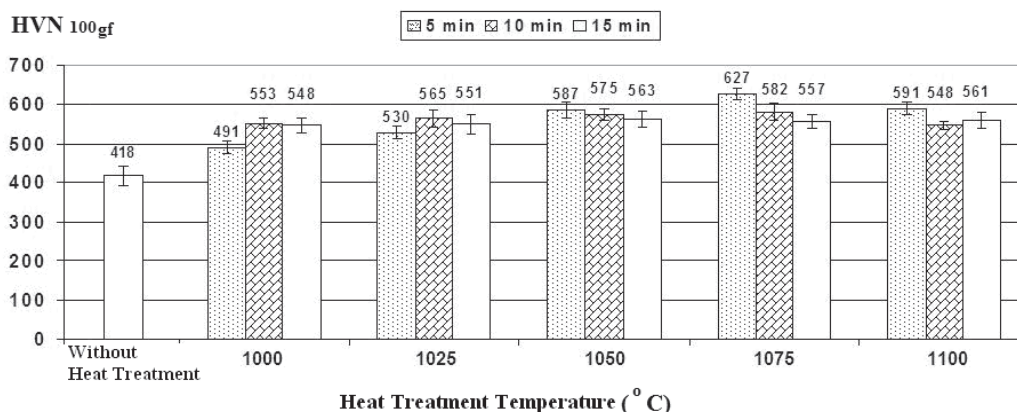
Fig. 8. The mean Microhardness values of coating surface of coatings treated at various temperatures and times

A comparison between the mean microhardness values of the coating surfaces is illustrated in Fig. 8. This figure shows the untreated coating surface has the minimum hardness, while the maximum hardness obtained at the surface of the coating treated at 1075 °C for 5 minute. The reasons for this behaviour were discussed earlier.
